Attachment 5
Photograph Log

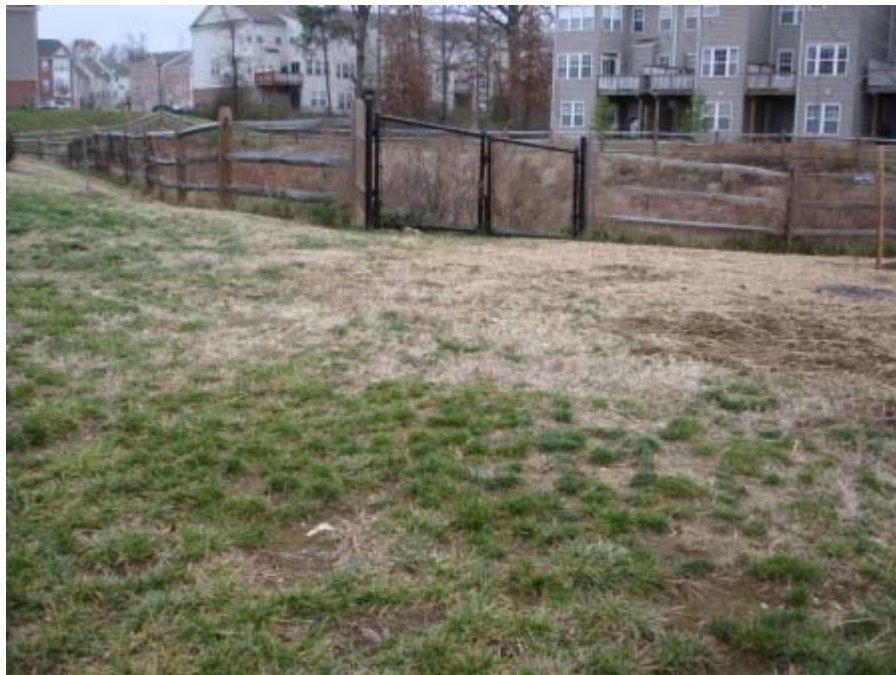
Photograph 6. River Oaks – Stormwater pond

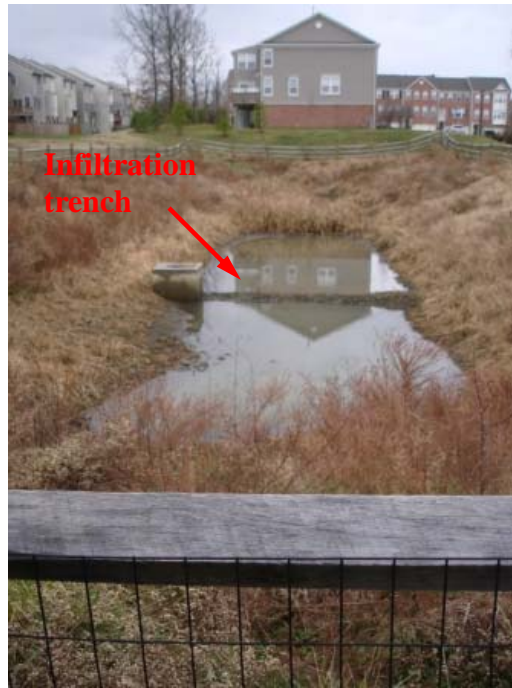
Photograph 7. River Oaks – Stormwater pond

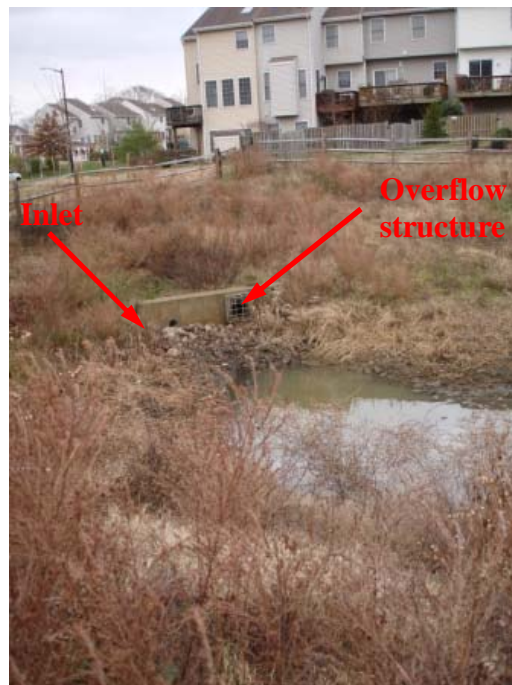
Photograph 8. River Oaks – Stormwater pond headwall

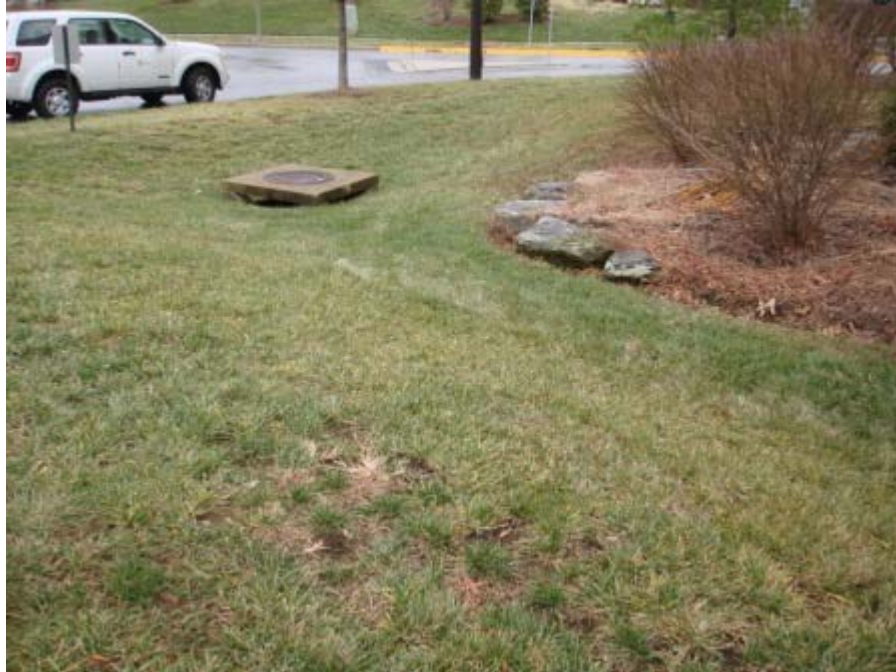
Photograph 9. River Oaks – Stormwater inlet

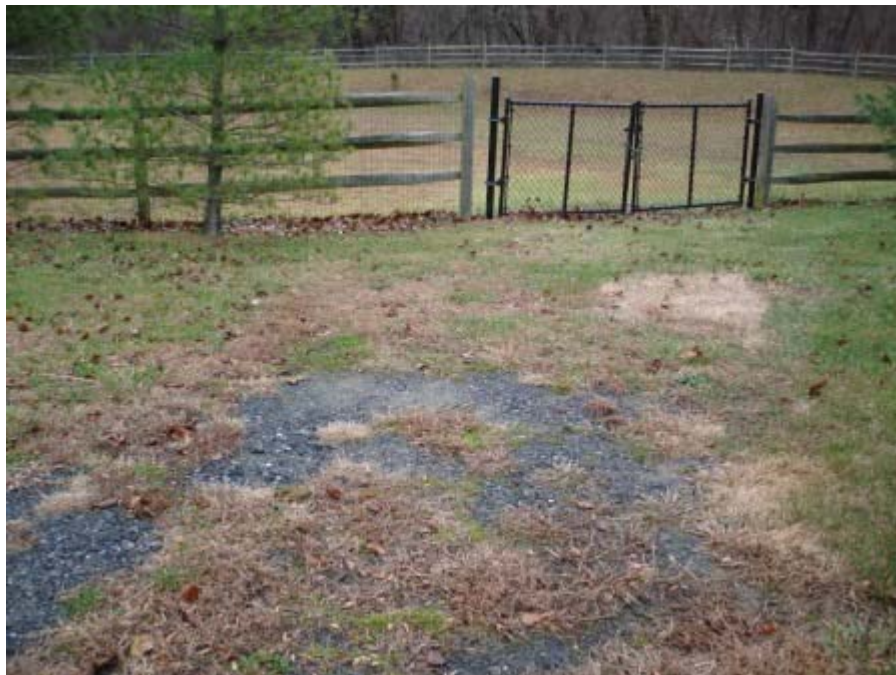
Photograph 10. Yorktown Manor – Stormwater pond

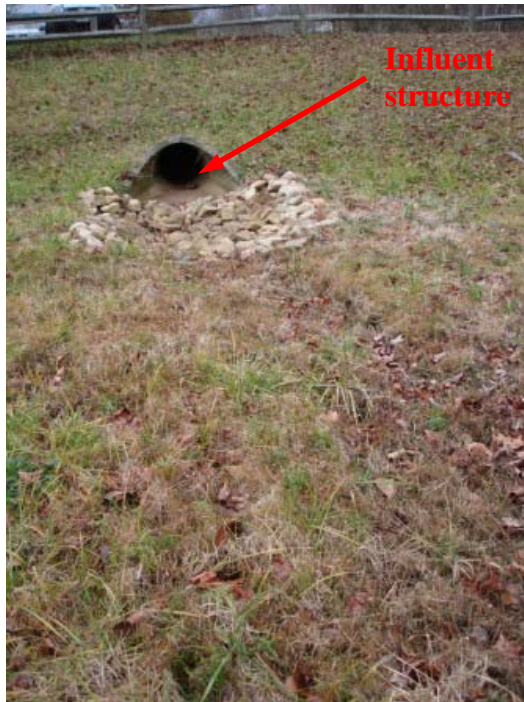
Photograph 11. Yorktown Manor – Inlet pipe

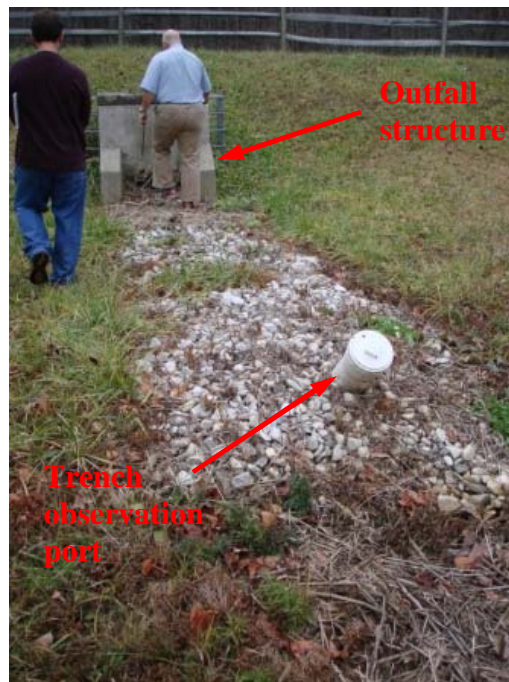
Photograph 12. Yorktown Manor – Infiltration trench

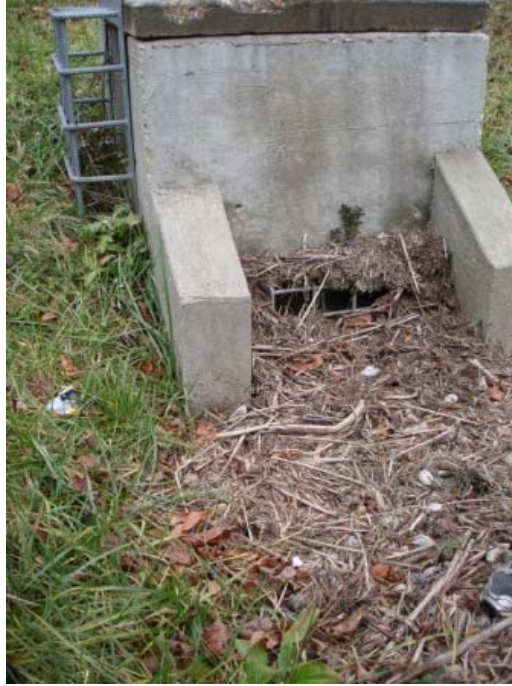
Photograph 13. Yorktown Manor – Outlet structure

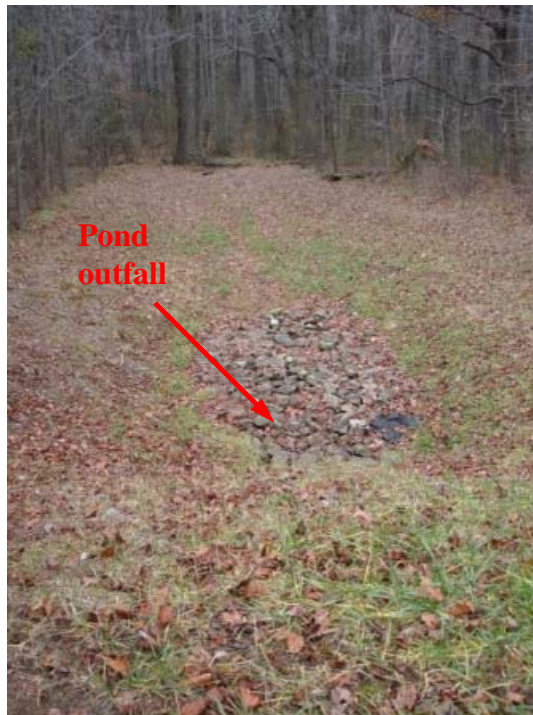
Photograph 14. Yorktown Manor – Outfall

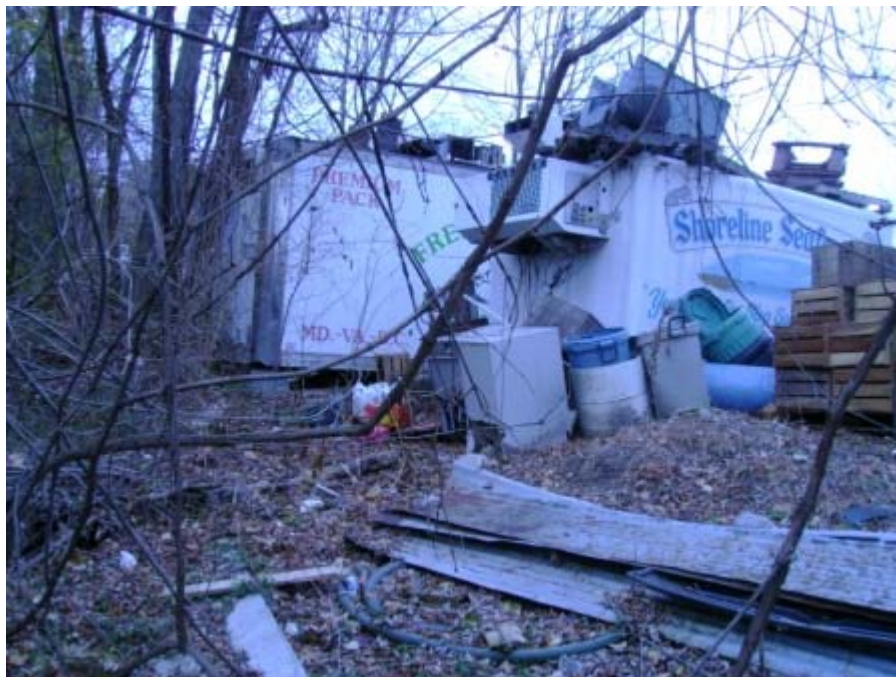
Photograph 22. Shoreline Seafood – Illicit Discharge Site Visit
View of area behind on-site storm drain with general storage.

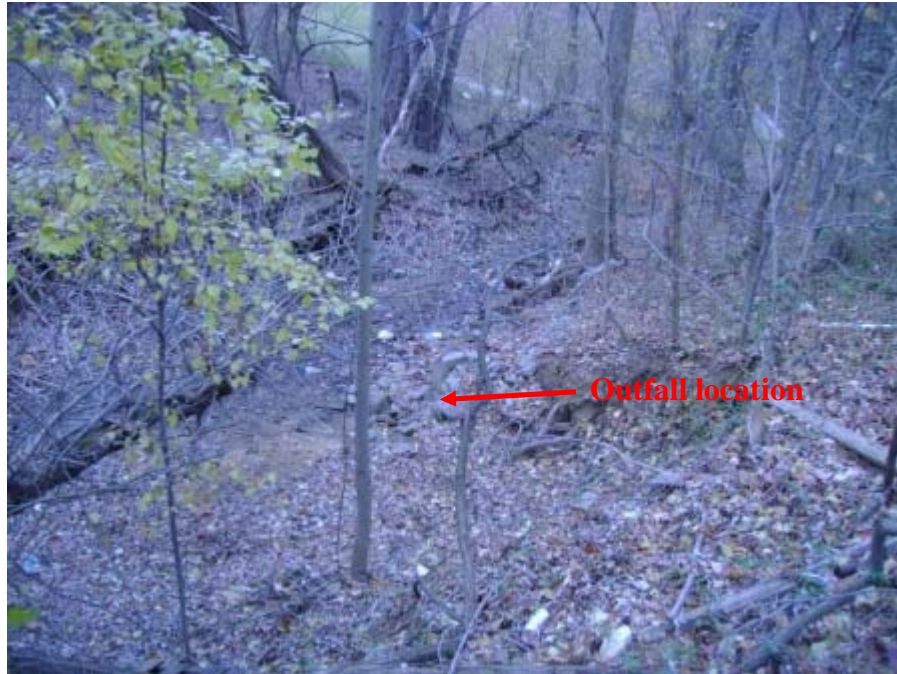
Photograph 23. **Shoreline Seafood – Illicit Discharge Site Visit**
View of outfall location from on-site storm drain to ephemeral stream.

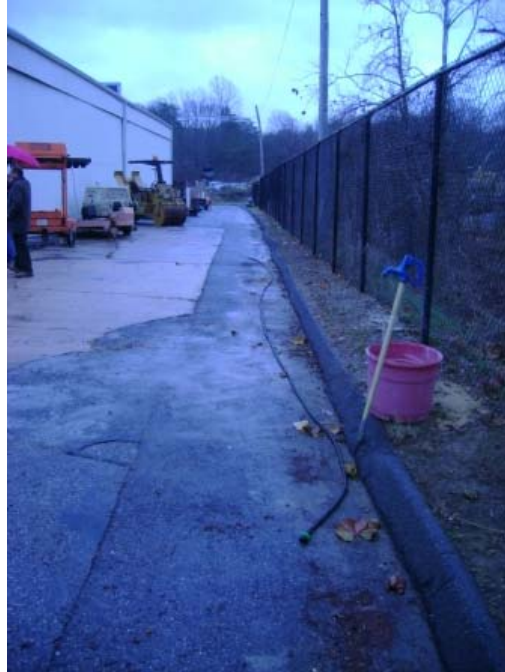
Photograph 31. Central District Roads – Crownsville Yard – County Properties
Another view of the vehicle/equipment wash area and view of the south property line facing east.

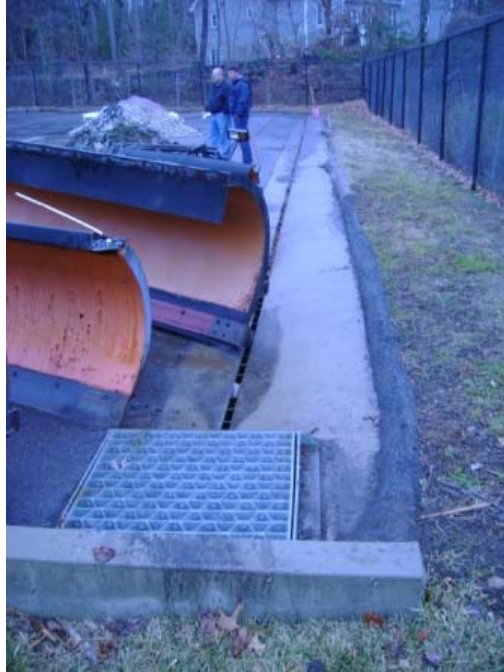
Photograph 35. Central District Roads – Crownsville Yard – County Properties
View of a trench drain along the east portion of the site and an additional inlet to the storm water management pond.

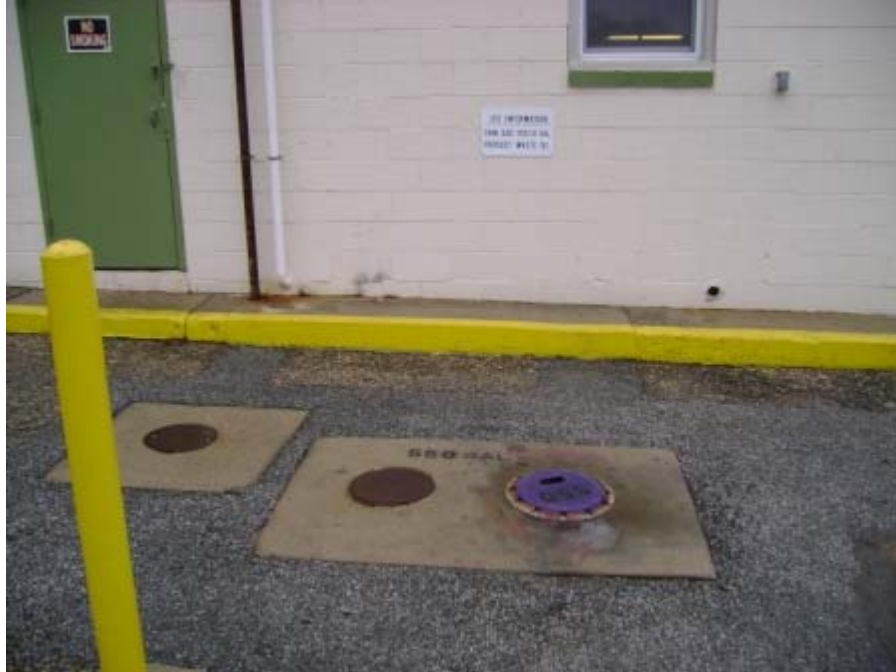
Photograph 43. Central District Roads – Crownsville Yard – County Properties
View of 550-gallon underground waste oil storage tank noted in Photograph 28

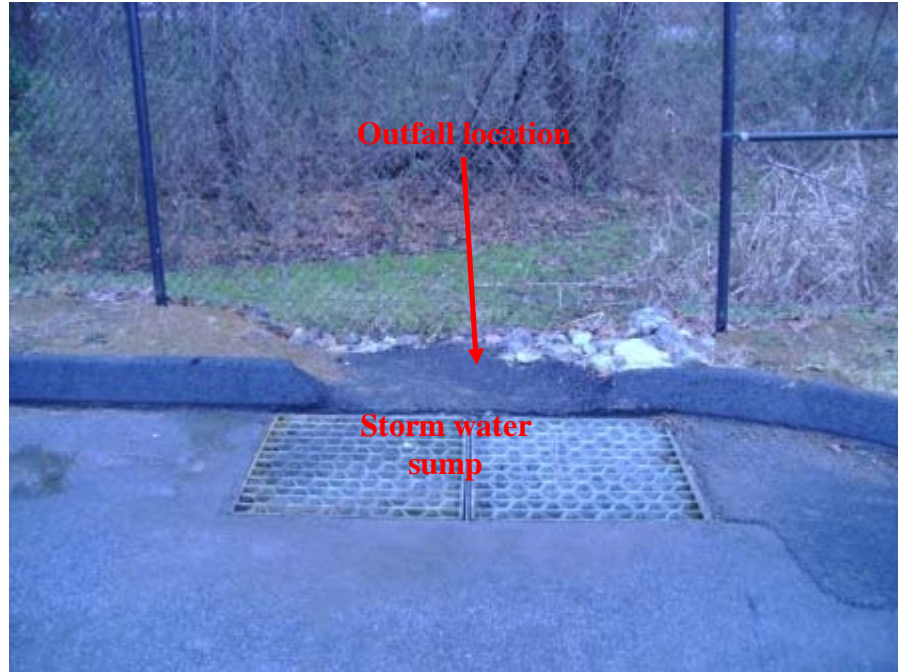
Photograph 45. Central District Roads – Crownsville Yard – County Properties
Sump and overflow location in south west corner of the facility noted in Photograph 30.

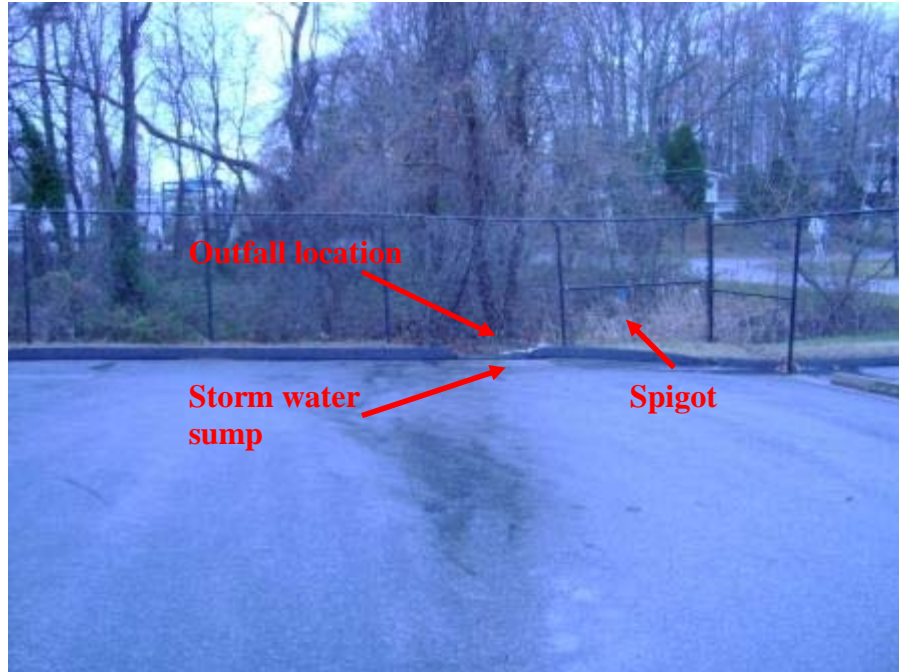
Photograph 47. Central District Roads – Crownsville Yard – County Properties
Overall view of the storm water sump, outfall location and spigot noted in Photographs 30 through 32).

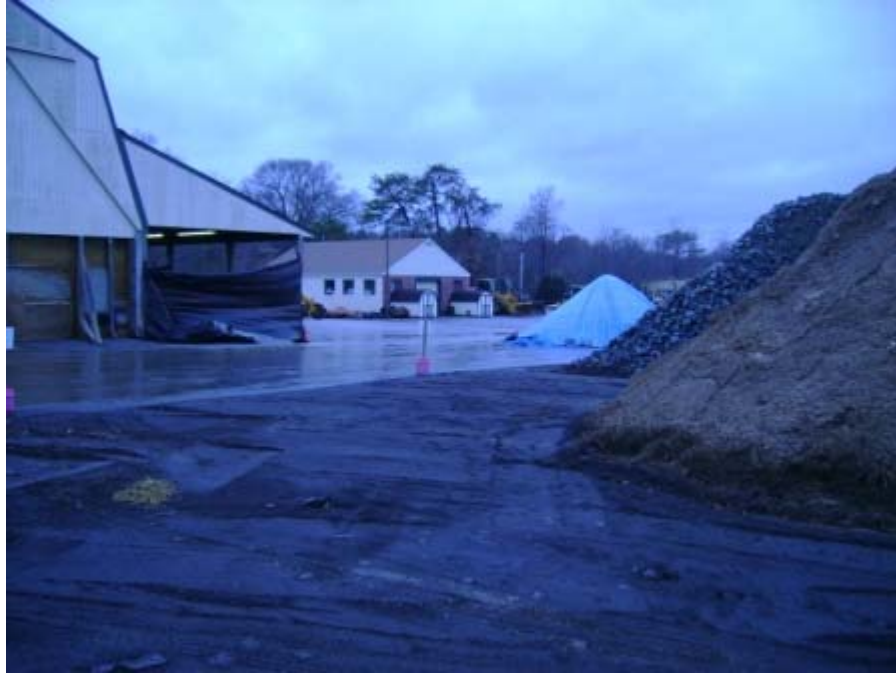
Photograph 51. Central District Roads – Odenton Yard – County Properties
View of uncovered and covered stockpiles in yard. (NOTE: Several storm drains are located throughout the yard)

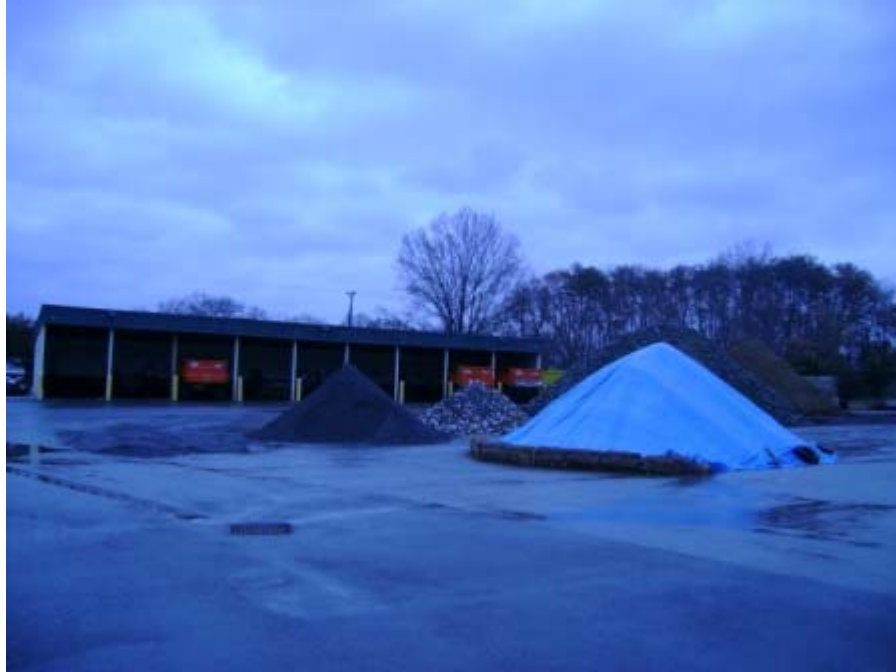
Photograph 55. Central District Roads – Odenton Yard – County Properties
Another view of uncovered and covered roadway material storage (e.g., sand, gravel, etc) identified in Photograph 37. (NOTE: Several storm drains are located throughout the yard)

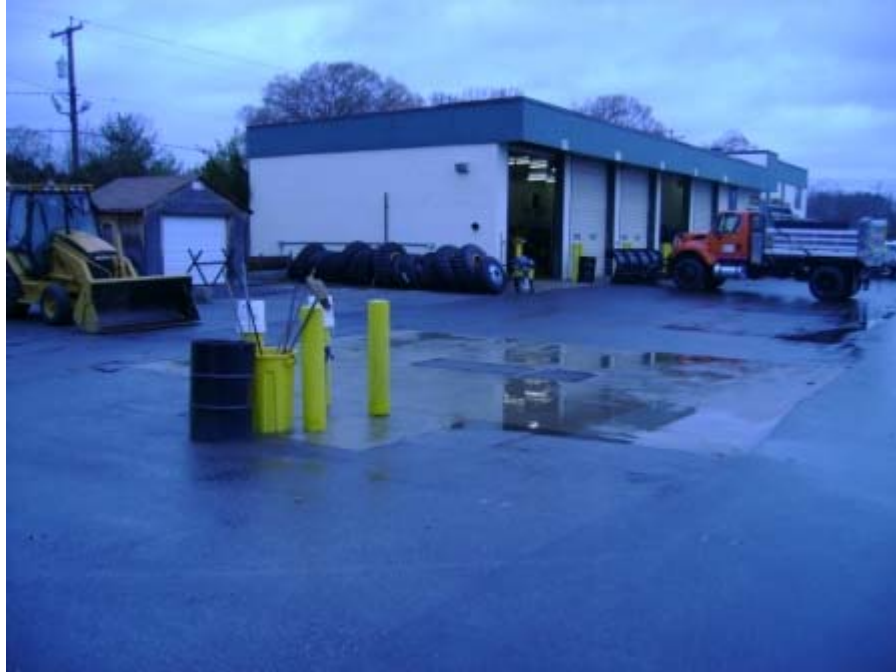
Photograph 57. Central District Roads – Odenton Yard – County Properties
View of wash pad (foreground) and maintenance shop (background). Washwater flows to
oi/water separator and to storm water management pond.

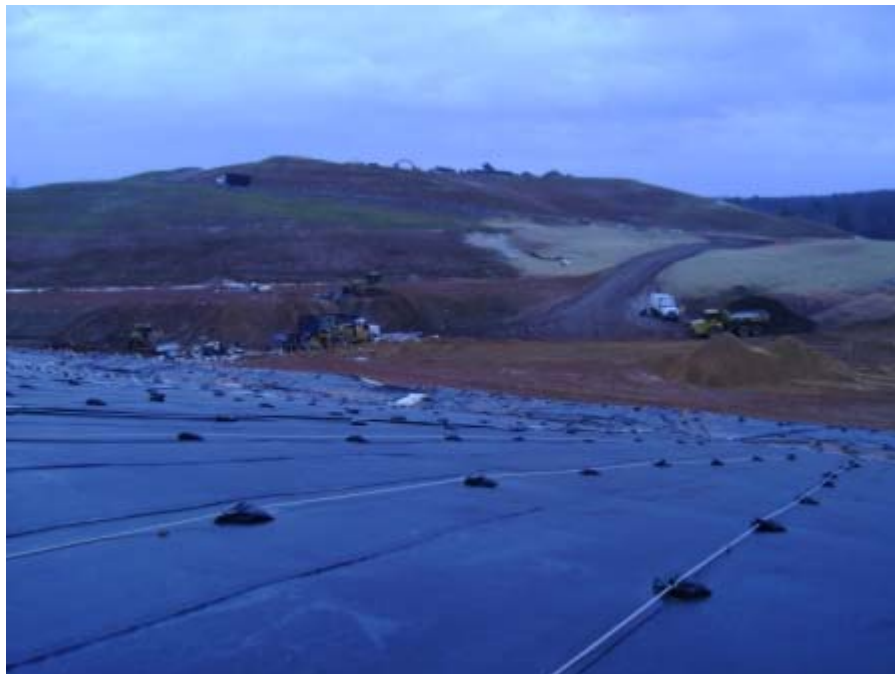
Photograph 64. Millersville Landfill and Resource Recovery Facility – County Properties
View of an active landfill cell.
